# Manhole Inspection Summary

Manhole # S29YY\_035MH

Insp Date: **5/22/07 10:28 AM**

**Location** Address: **522 BEECHE AVE**

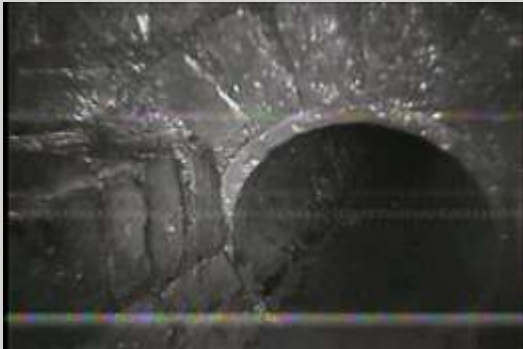
### 10 in. Circular Gravity Sewer Pipe Out @ 12 O'Clock

Invert Depth: **14.25** (ft.) Flow Characteristics: **Slow**

Deposits: ☒ None ☐ Mud ☐ Sludge ☐ Debris ☐ Grease

Infiltration: **None** Pipe Seal Cond: **Unknown**

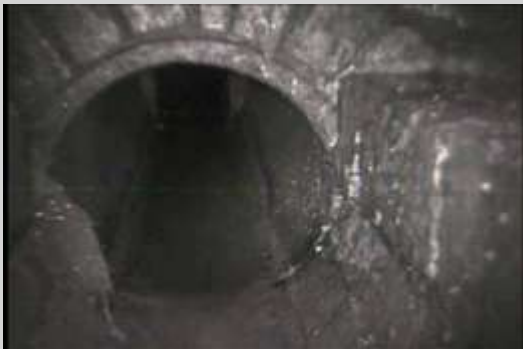
### 10 in. Circular Gravity Sewer Pipe In @ 3 O'Clock

Infiltration: **None** Pipe Seal Cond: **Unknown**
